Report on the investigation of
a sea cadet's fatal accident on board
the sail training ship

TS Royalist

2 May 2010

Report No 2/2011
March 2011

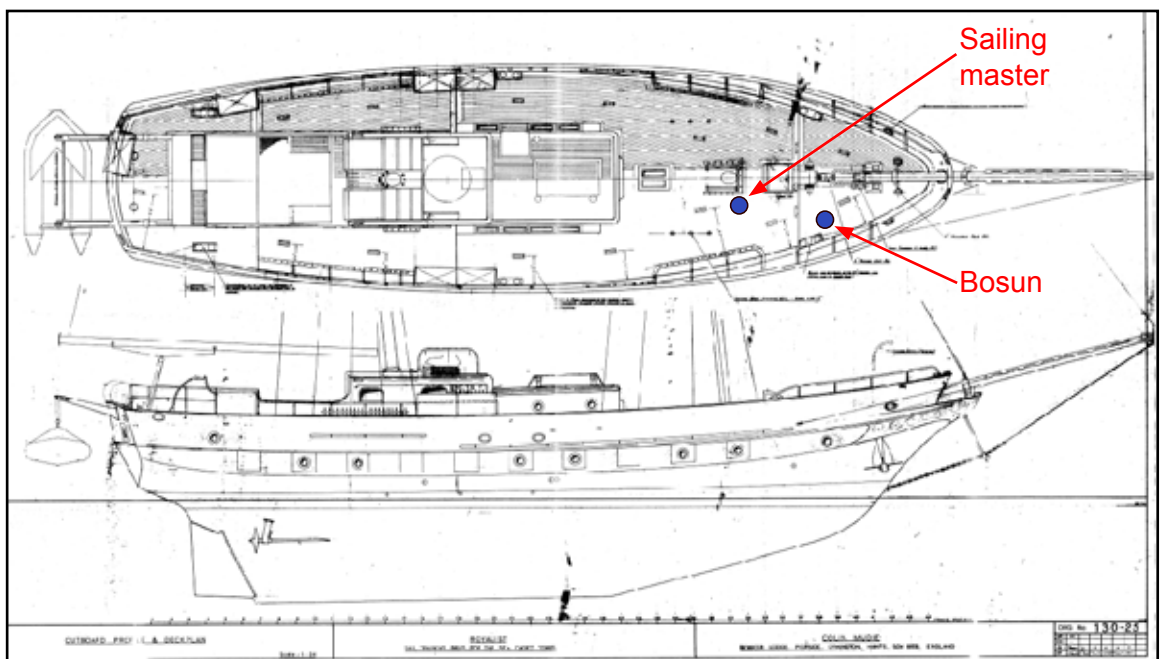
The main course was quickly furled and several cadets were sent from the main mast to assist the cadets working on the fore mast. The sailing master also went forward but remained aft of the bosun on the vessel's starboard side (**Figure 5**).

Approximate locations of sailing master and bosun

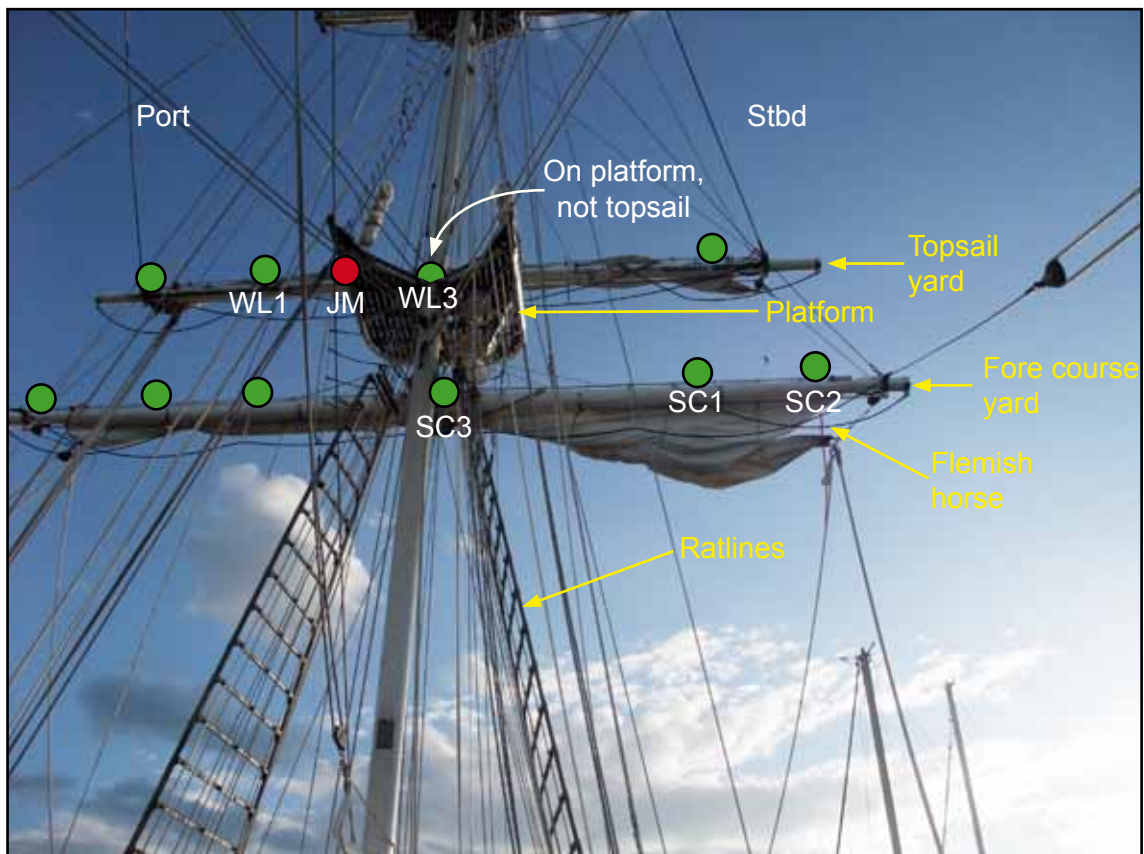
Figure 6

On the fore mast, four cadets were furling the fore topsail. One cadet was on the starboard yard and three cadets were on the port yard (**Figure 6**). Jonathan helped WL1 to stow the sail on the port yard while guiding a less experienced cadet on the port course yard below. WL1 was having difficulty in managing the task she had been set and, although not told to do so, Jonathan moved across to the starboard topsail yard to assist the lone cadet.

Six cadets were nominated to furl the fore course sail. Three cadets were on the port yard and two cadets (SC1 and SC2) were on the starboard yard; SC1 was about midway along the yard and SC2 was standing in the Flemish horse at the yard arm (**Figure 6**). SC2 was having difficulty in leaning over the yard to furl and secure the sail, and did not feel comfortable. The sixth cadet, the starboard forward watch leader (WL3), also felt uncomfortable aloft and remained on the platform or 'top' around the mast between the fore course and topsail yards.

Position of the cadets on the fore mast

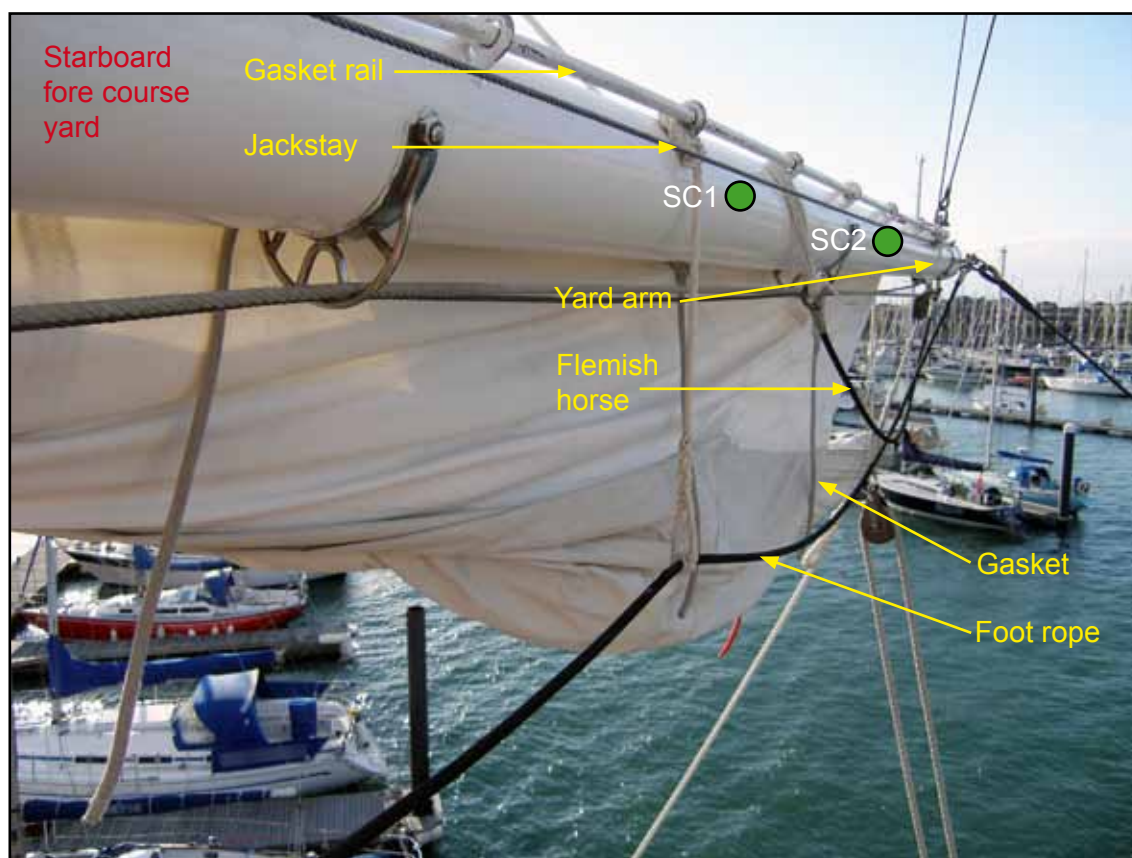
Figure 7

Jonathan climbed down from the platform via the futtock shrouds; it is not known if he clipped onto the vertical safety line available during this descent. He then stepped on the course yard foot rope between SC3, who was standing close to the mast, and SC1. Jonathan then clipped his belt harness lanyard on to the wire jackstay (**Figure 7**).

Starboard fore course yard

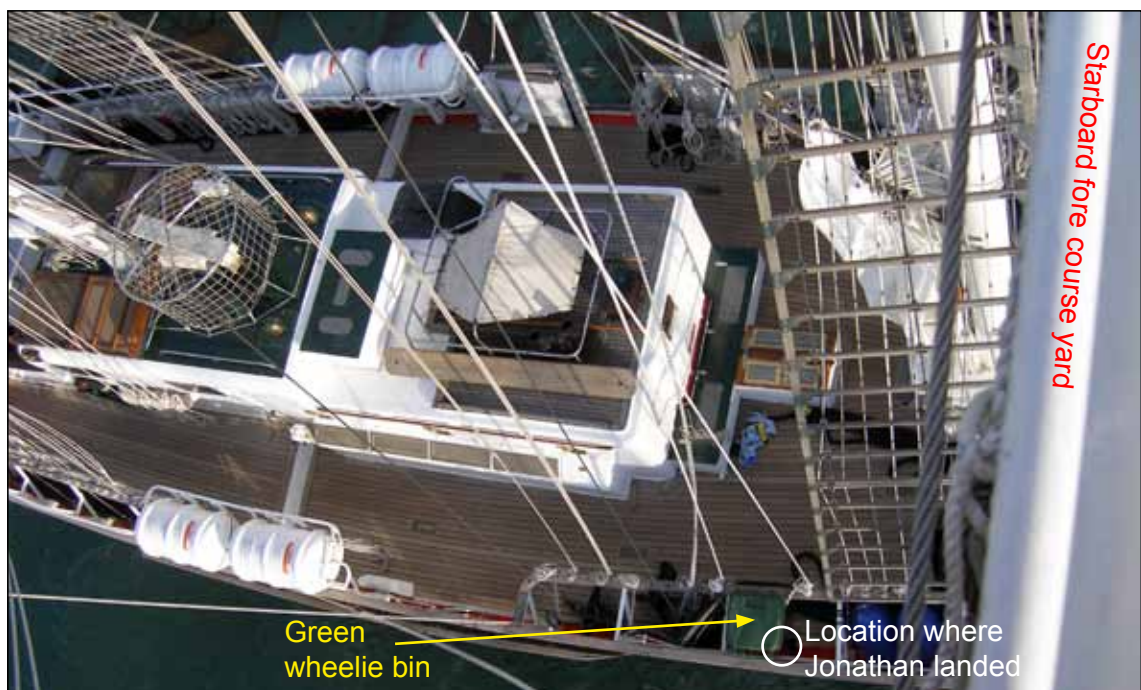
Figure 8

Jonathan landed face-down on the starboard gunwale and a green wheelie bin (**Figure 8**). He then fell in to the sea. Jonathan quickly surfaced face-up; his arms were outstretched and he showed no signs of movement. Although both the sailing master and the bosun caught sight of Jonathan as he fell, neither knew which yard he had fallen from.

View of deck from starboard fore course yard
